Degradation of land in the territory of the municipality of Lipjan

Mr.Sc. Semir GASHI

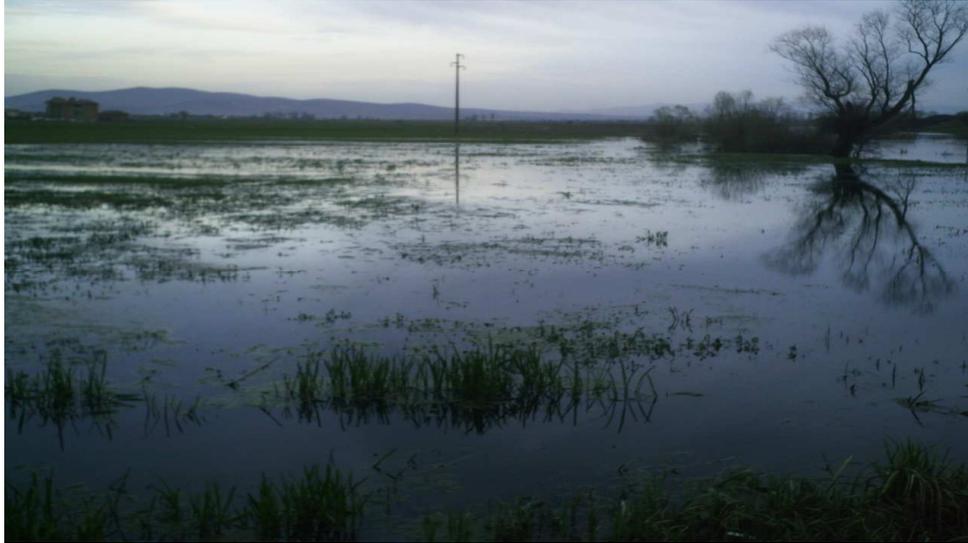
Pic 1 Sitnica river flooding

Flooding: floods wash humus matters in soil and compress soil structures. Flooding is rather frequent, especially in early springs, along the Sitnica River and in periods of large intensity of precipitation collected by its branches.

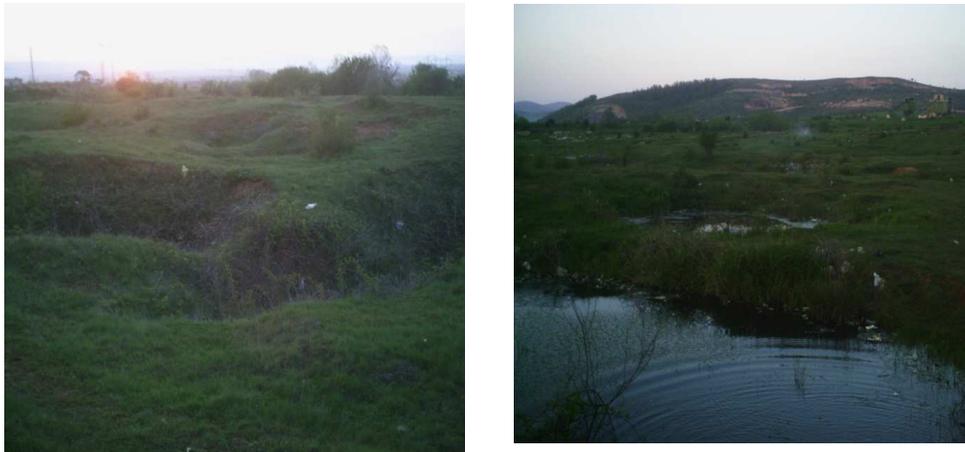
Foto 2. Degradation of lands after depletion of coal mine of Babush, and higher in the hills, one can see the exploitation of lime stone in Gadime.

One of the most obvious cases of soil degradation may be seen some 15 km south-east to Lipjan, in the area between villages Babush-Gadime and Cërrnillë, which was earlier used for coal mining – lignite, at a depth of 28 meters, in a

total surface area of 10.30 ha, in the coal mine “Babushi i Muhaxhirëve”², which is not operational anymore, but the channels or shallow corridors of the coal mine have remained, which often is subject to collapses and the soil layer in this area is fully devastated, with funnel-form holes which are dead and filled with water. This area is not being used as a waste landfill, which only contributes further to the environmental hazard. This degraded area can be cultivated with saplings of pine, and even be fenced, to provide for the formation of a rather good ecosystem, rich in flora and fauna, for a beautiful area to be in.

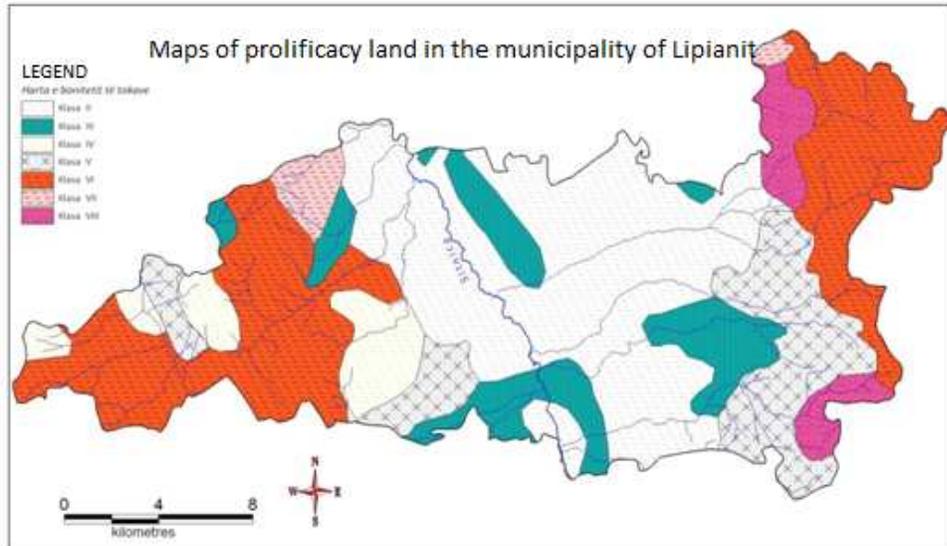
Source: Mapping Kosovo land classes, Basis of Hydro-Economics in Kosovo, Hydro-Economic Institute "Jerosllav Ćerni" Belgrade, 1981. processed by the author.
